# The Shattered Clue: Evaluating Glass Fractures at a Burglary Crime Scene

## Case Overview:

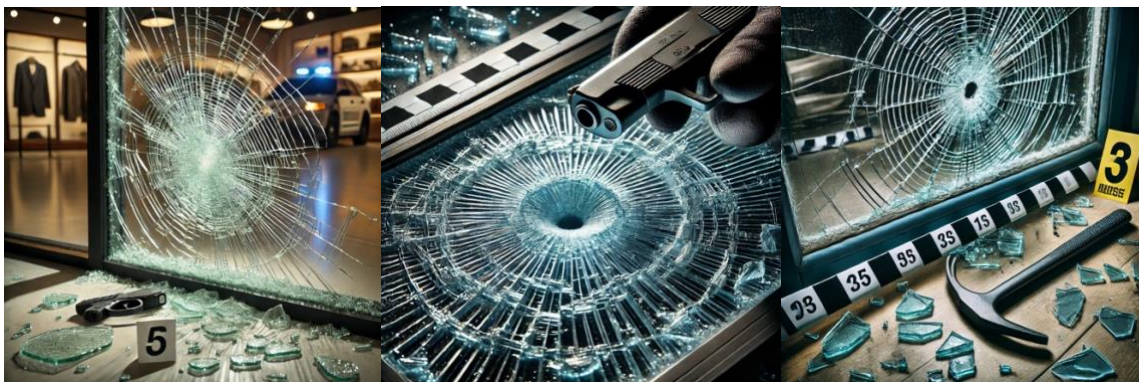
- **Photo 1:** Shows the point of impact, with clear radial fractures extending outward from the center. The impact point indicates the object hit the glass at a high velocity.
- **Photo 2:** Displays concentric rings forming around the impact site, suggesting that a significant amount of force was applied. These patterns helped confirm the window was broken from the outside.
- **Photo 3:** Highlights the tool marks on the window frame and the edges of the glass where the crowbar may have been used.
